Manhole Inspection Summary

Manhole # S31S__001MH

Insp Date: **9/2/08 9:22 AM**

Location Address: **w ostend st**

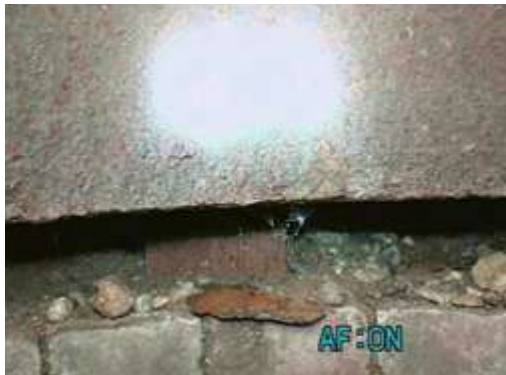
Defect 3

Chimney / Frame Adjustment ☒ Exists Material: **Brick** ☐ Parged Height: **2** (in.)

Condition: ☐ Sound ☐ Cracked ☐ Root Intrusion ☐ Loose Brick ☒ **Deteriorated**

deteriorated, frame adj

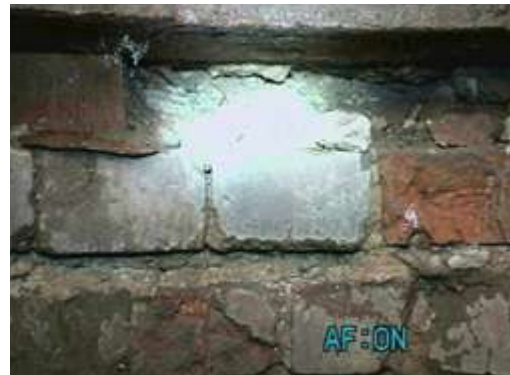
Defect 2

Corbel Material: **Brick** ☐ Parged Type: **Concentric/Eccentric**

Condition: ☐ Sound ☐ Cracked ☐ Root Intrusion ☐ Loose Brick ☒ **Deteriorated**

corbel deteriorated

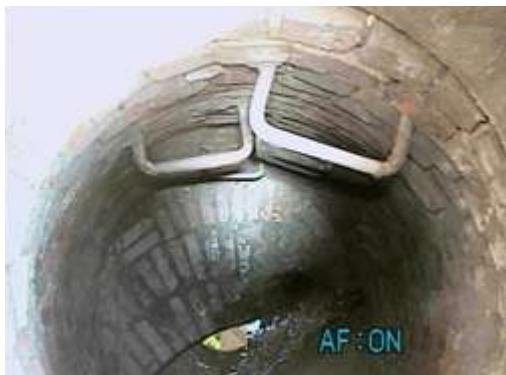
Defect 1

Steps Count: **4** Missing: **0** ☒ **Corroded**

steps

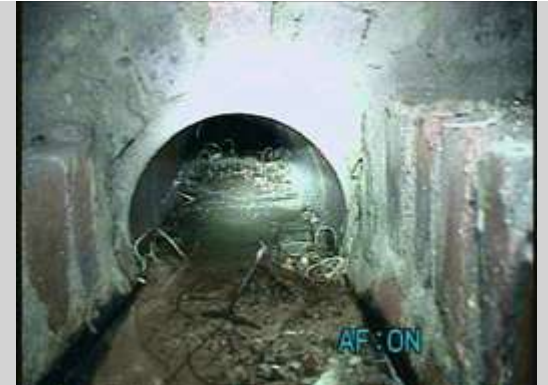
12 O'Clock Outflow

8 in. Circular Gravity Sewer
Pipe Out @ 12 O'Clock

Invert Depth: 8.20 (ft.) Flow Characteristics: **Slow**

Deposits: ☐ None ☒ Mud ☒ Sludge ☐ Debris ☐ Grease

Silt Depth: 3 (in.) Deposits Extent: **Light**

Infiltration: **None** Pipe Seal Cond: **Roots**

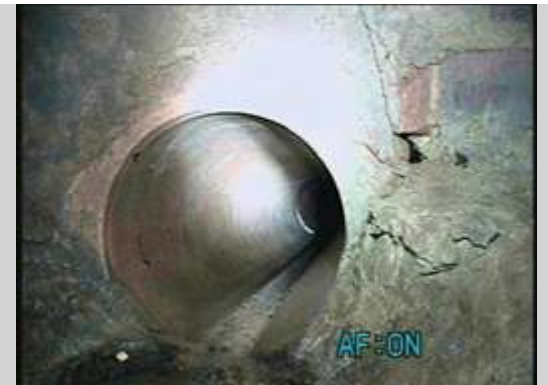
6 O'Clock Inflow

8 in. Circular Gravity Sewer
Pipe In @ 6 O'Clock

Invert Depth: 8.10 (ft.) Flow Characteristics: **Slow**

Infiltration: **None** Pipe Seal Cond: **Unknown**
